Condition Report and Treatment Proposal

Title: Spanish - American War Soldier
Location: W. Wisconsin Ave at N 10 th. St. (Median) Milwaukee, WI
Owner : City of Milwaukee
Artist: Ferdinand Koenig
Material: Bronze on Granite base
Dated: 1932
Examined: 02-2014

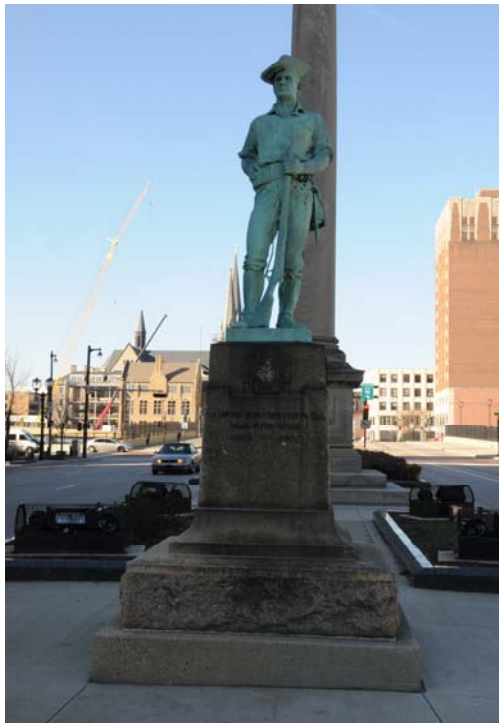
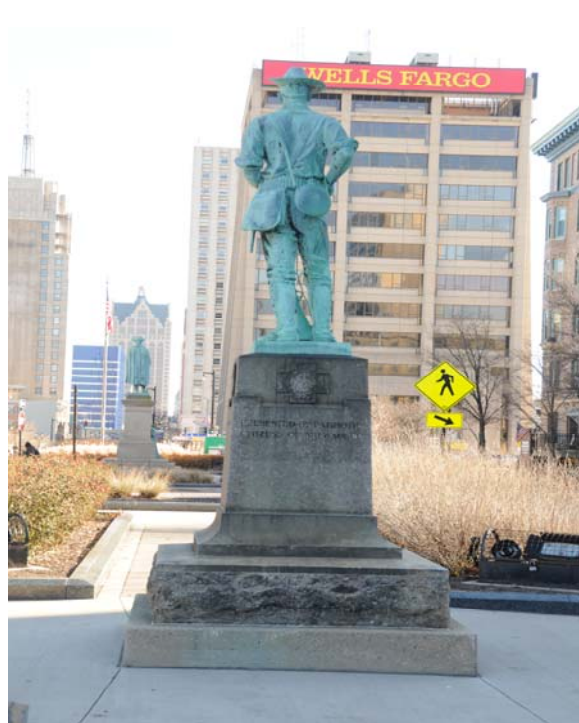
The sculpture has been exposed to an outdoor environment for a number of years. The entire surface is covered with dirt, dust, and corrosion products. The bronze elements present typical green and black corrosion

products which disfigure the design of the monument. The surface is corroded relatively evenly. The entire sculpture is covered with light green corrosion and spots and streaks of black copper sulfides. The most disfiguring black streaking is found on the legs of the soldier.

It appears that all of the original parts of the sculpture are intact. No evidence of replacement parts was found during examination. The sculpture appears to be well attached to the base.

1. Erect a scaffolding and thoroughly examine the external surface of the bronze in order to correctly assess the condition. Some unseen condition issues may be discovered.

2. Clean the surface of the bronze using:

Option A: bronze wool and brass brushes in order to remove all of the loose corrosion products.

Option B: laser ablation process in order to remove all of the corrosion products.

3. Wash with steam and 5% solution of Orvus Non-Ionic Detergent using tampico scrub brushes.

4. Patinate the surface of the sculpture:

Option A.

- patinate the entire surface of the sculpture brown.

Option B.

- patinate the black areas green to match the appearance of the corrosion products.

Option C.

- patinate the black areas green, and then add brown patina to change the tone of green to slightly brown/green.

5. Coat the sculpture with hot applied microcrystalline wax or Incralac.

6. Apply a sacrificial cold-wax coating and buff-out using soft cotton rags.

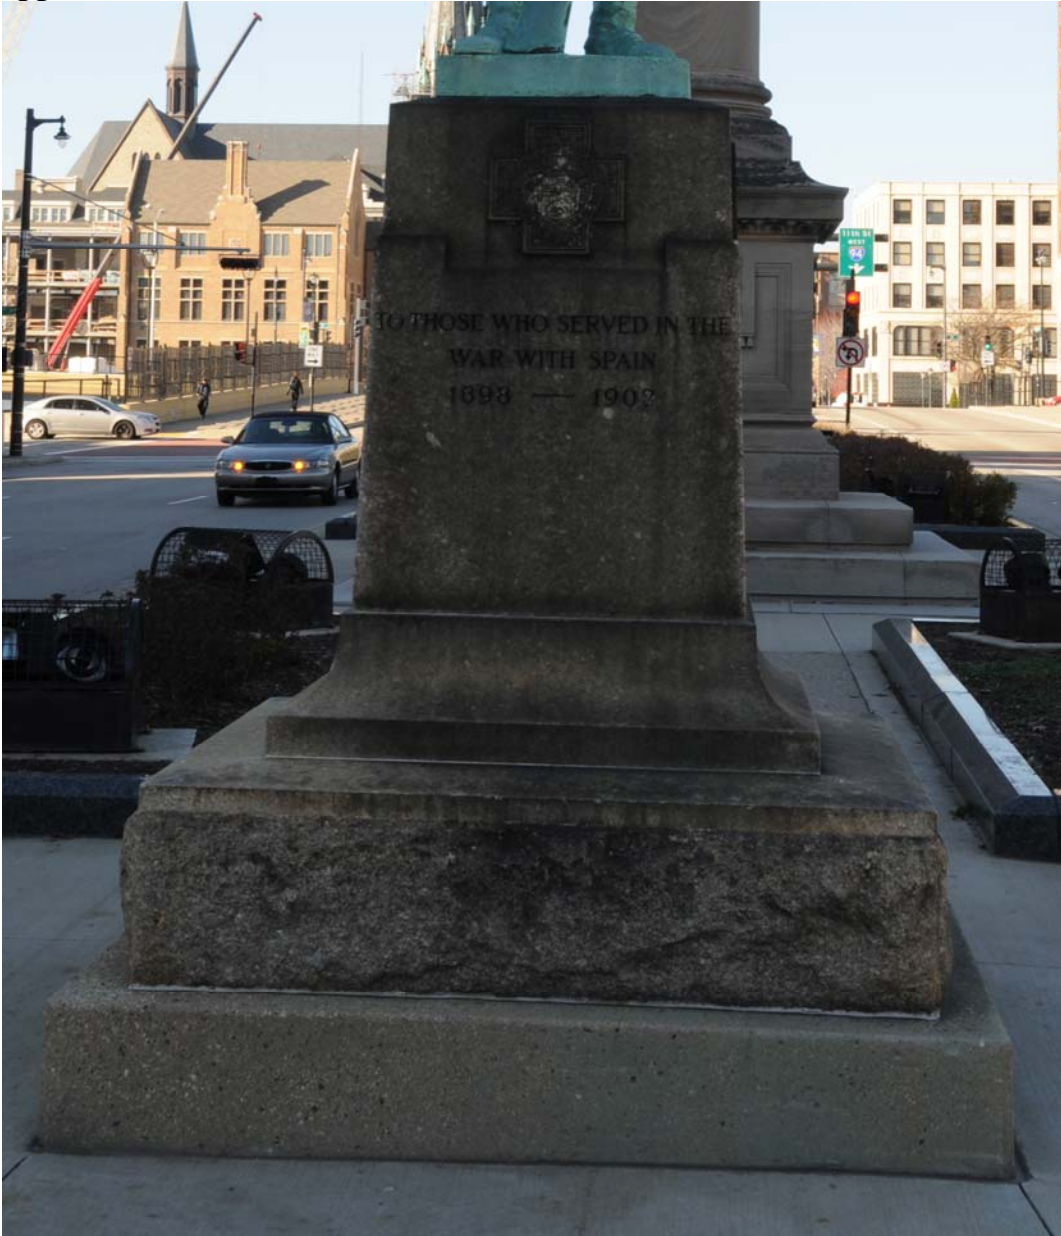
The stone is covered with black presumably carbon based deposits from air pollution. The monument is located in an area with a lot of car traffic, which explains the discoloration. The stone appears to be structurally stable.

1. Test cleaning protocols in small areas for approval, and after owners approval clean the stone.

- A. Wash with warm water and a 5% solution of Orvus Non-Ionic detergent using low pressure washing (under 200psi).
- B. Remove the black staining after testing for the most appropriate method.
- C. Tack point the stone where needed.
